# St. Mary's Episcopal Church

Wayne, Pennsylvania

2024 Transition & Transformation  
Maintenance & Repair Work Items

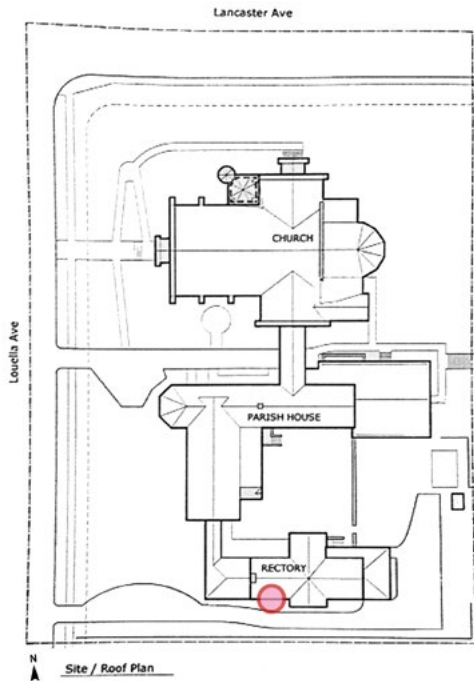
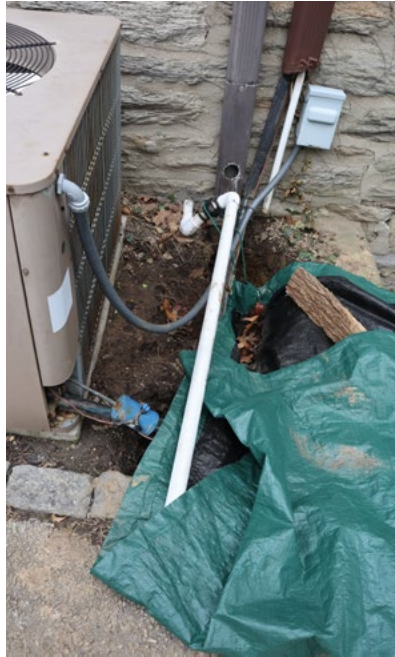
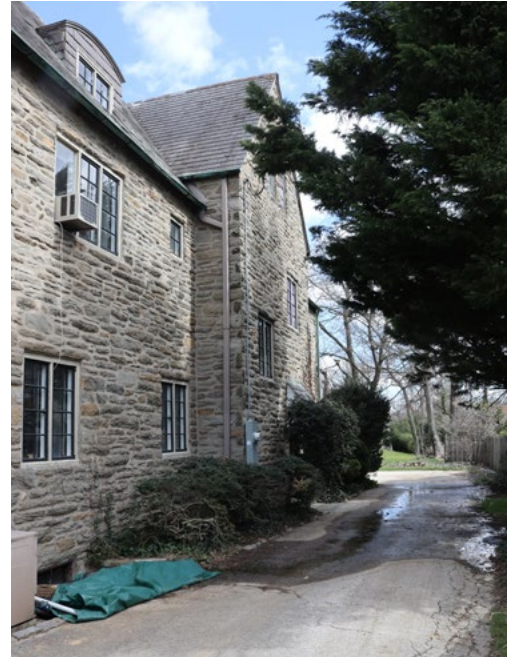
## Rectory Driveway Downspout

**Issue:** One of the underground stormwater pipes which collects water from a downspout on the Rectory south side has failed. It is also the outlet for the new basement sump pump on the south side of the rectory basement.

**Temporary solution:** Sump pump outflow diverted to driveway and adjacent rip-rap.

**Solution:** Hire stormwater system contractor to identify location of failure, excavate and replace as required to restore to working order. May include patching driveway.

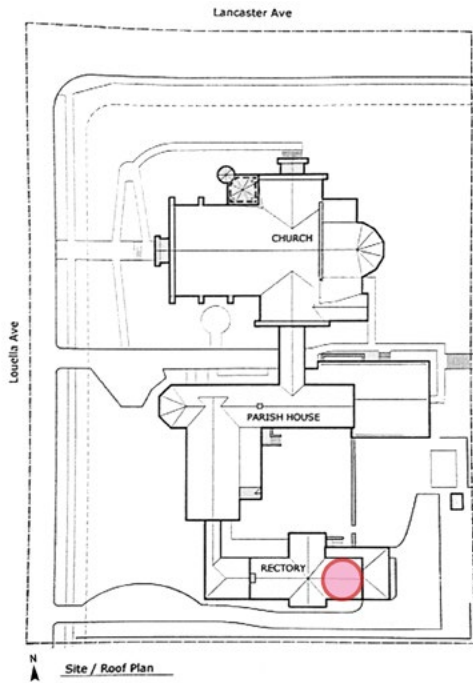
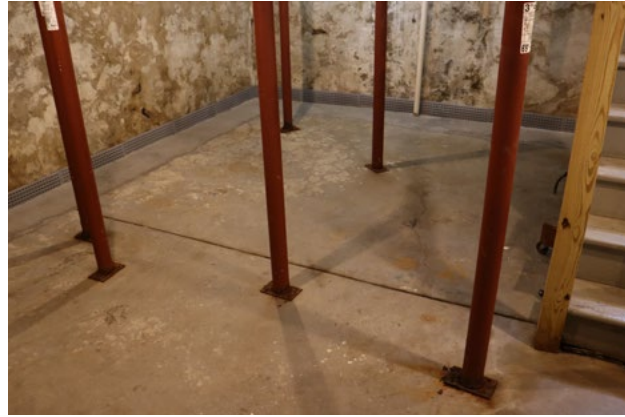
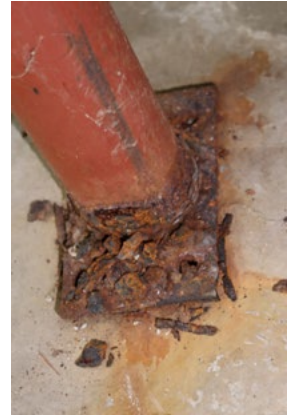
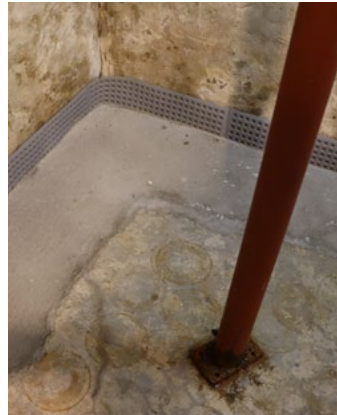
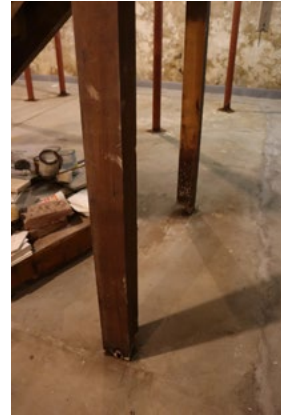
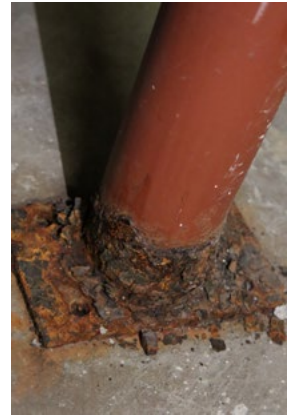
## Rectory Basement Support Posts

**Issue:** Persistent flooding has caused deterioration of lally columns and wood posts

**Solution:** Hire General Contractor to provide and replace in kind.

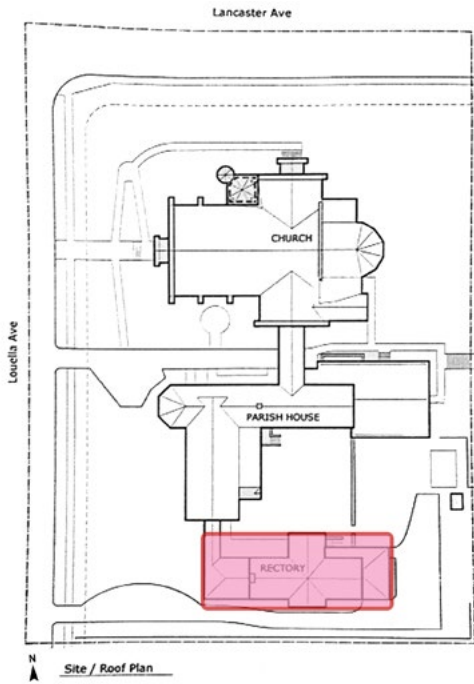
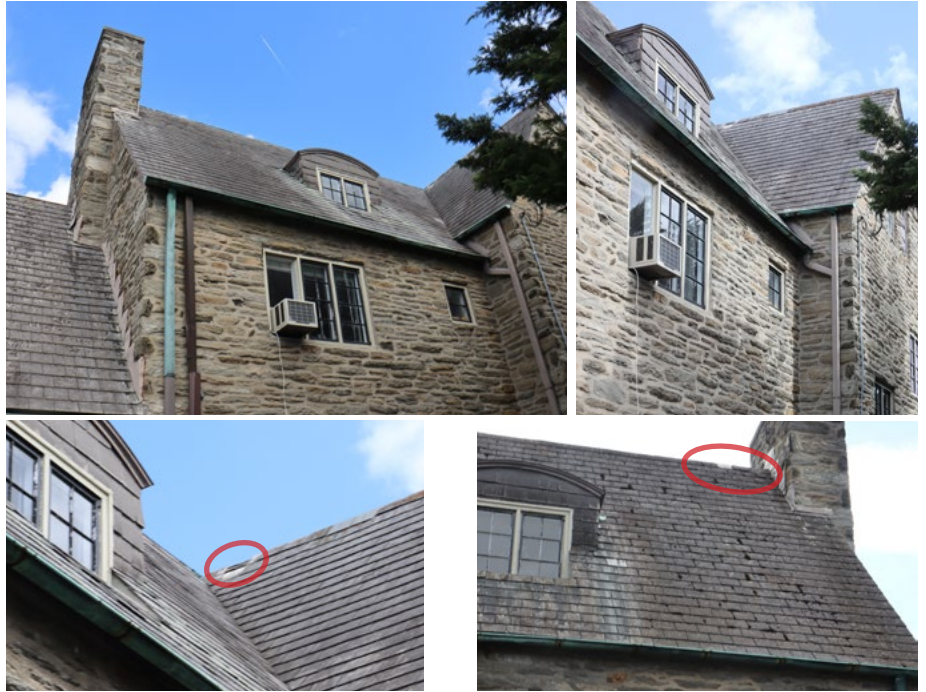
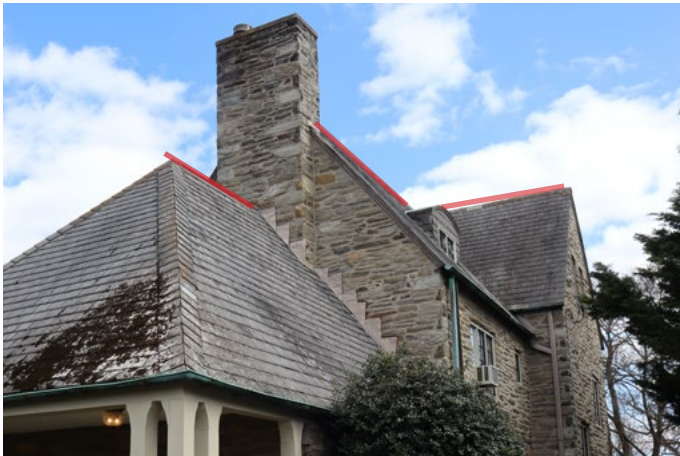
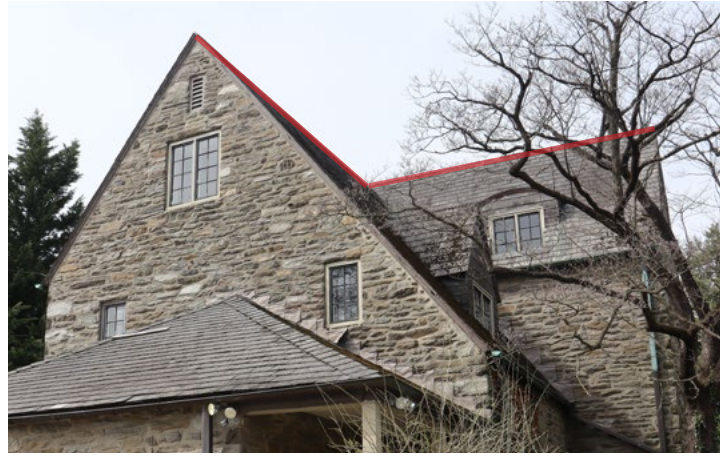
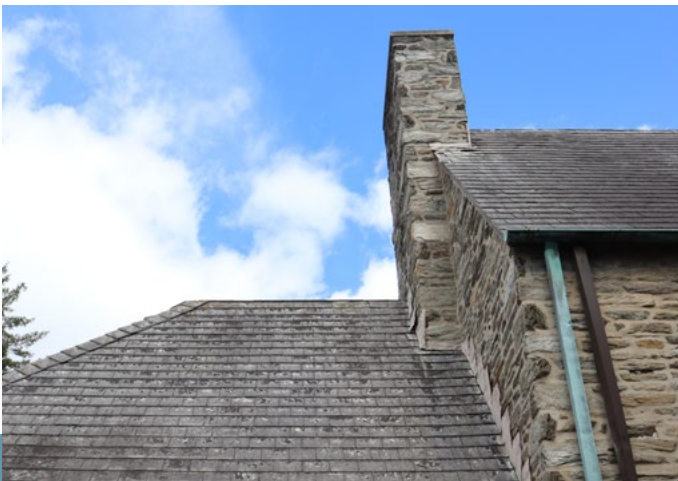
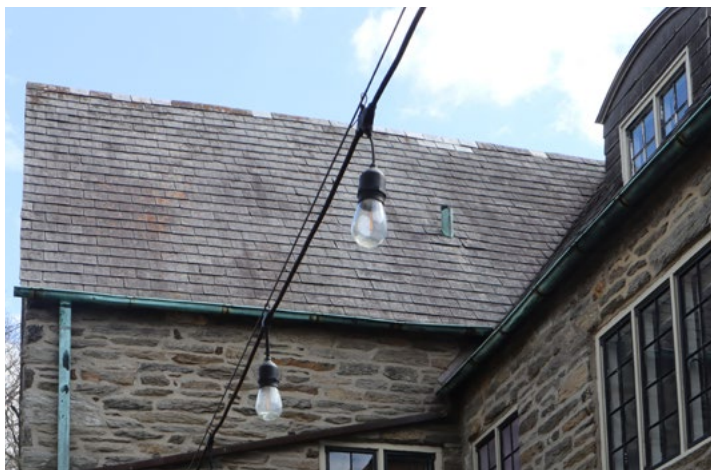
# Rectory Roof Tiles & Ridge Cap

**Issue:** 30+ year old cement-fiber roof shingles have worked loose on ridge line. Some are missing entirely.

**Solution:** Hire Russell Roofing to repair with modern replacement shingles with similar appearance, install aluminum ridge cap to reduce future delamination. Requires renting lift.

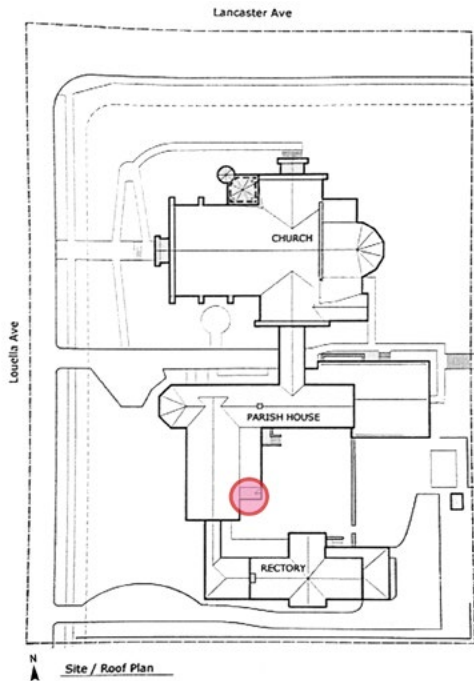
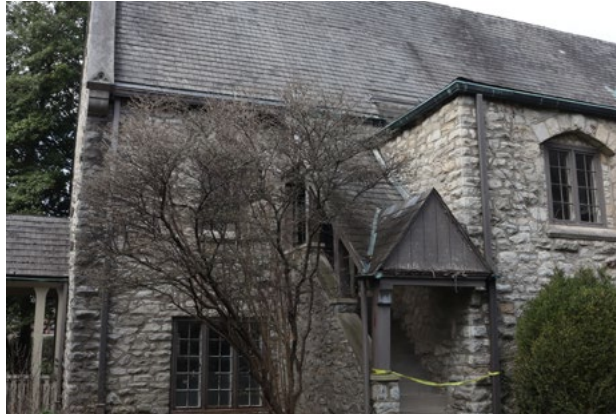
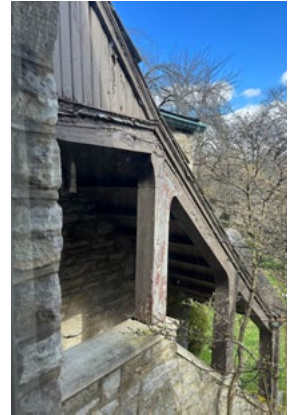
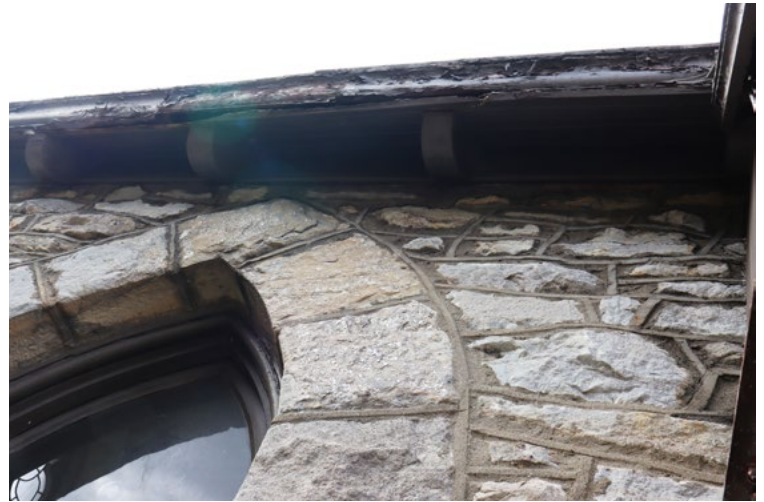
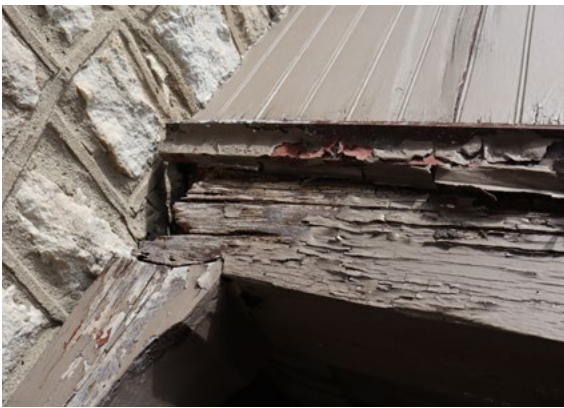
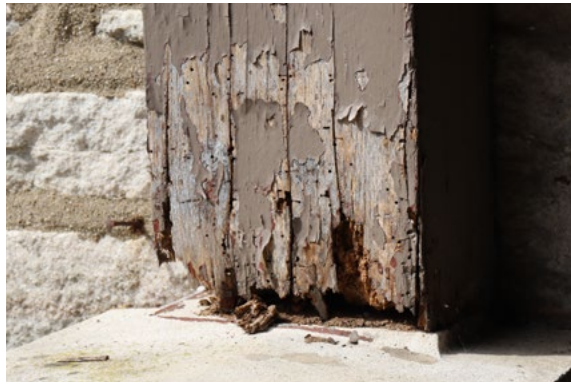
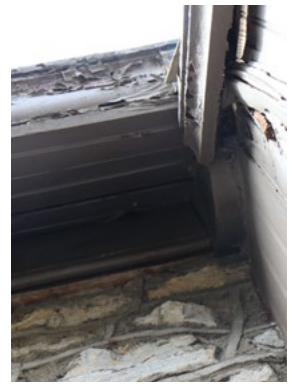
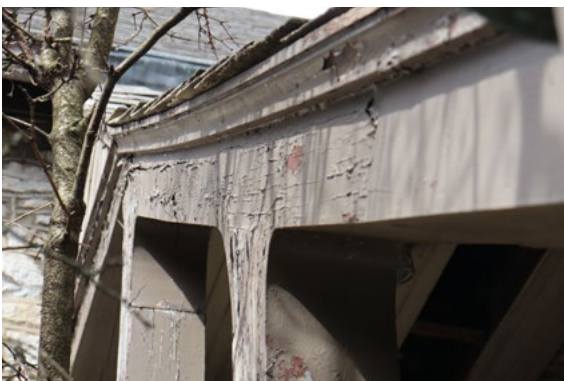
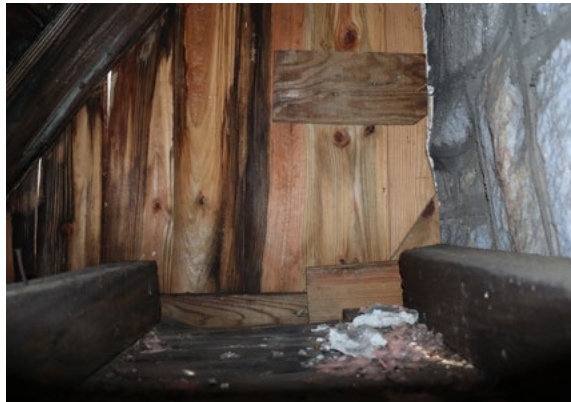
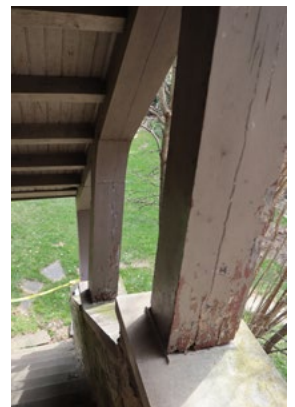
# Fr. Greene Room Fire Exit Roof and Wood Frame

**Issue:** Joint in copper gutter has been leaking for years, extensive water/rot/insect damage to crown molding, eave, T&G siding, and timber frame of fire exit stair roof canopy.

**Solution:** Hire Russell Roofing to repair gutter seam. Hire carpenter to repair/replace rotted wood. Paint new & existing 2 coats.

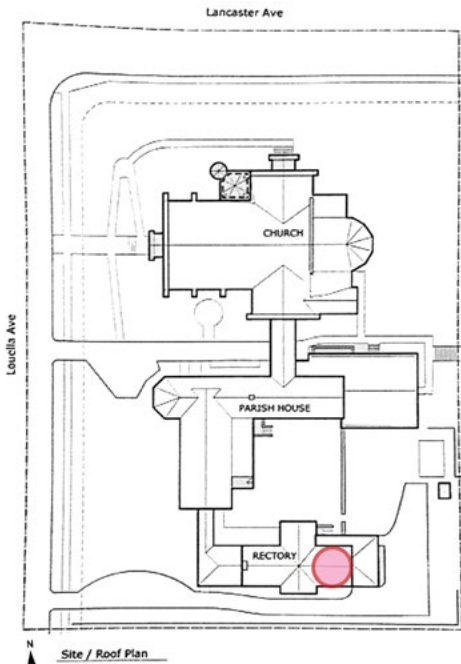
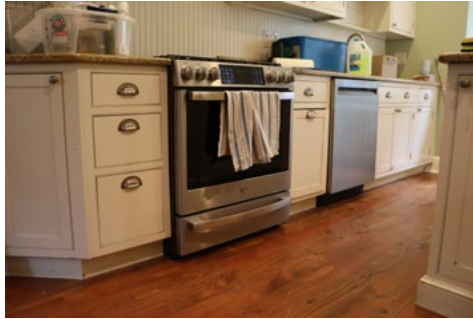
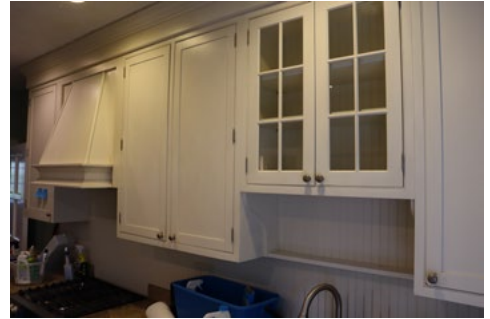
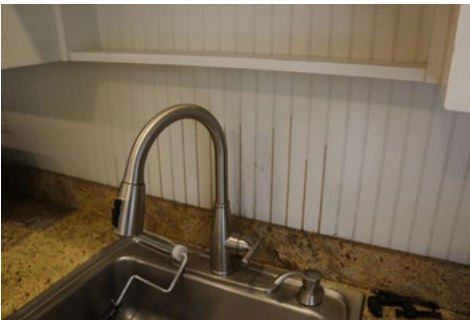
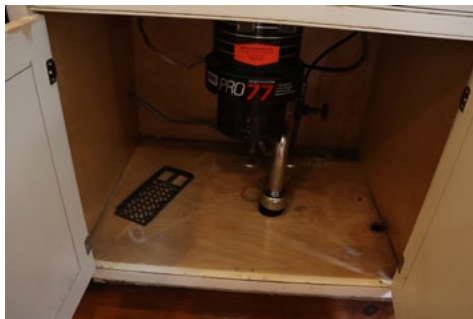
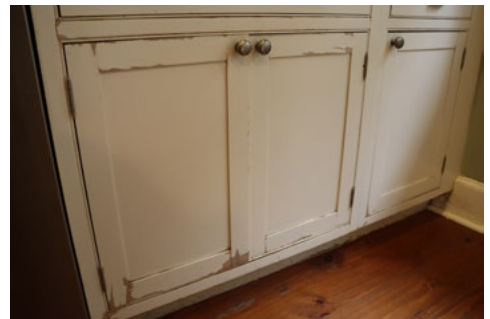
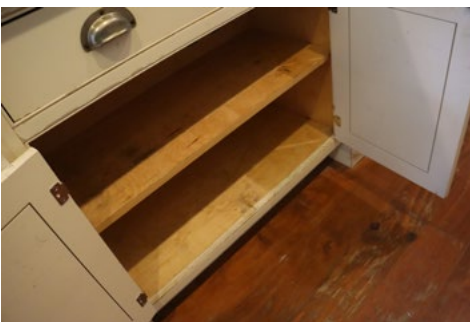
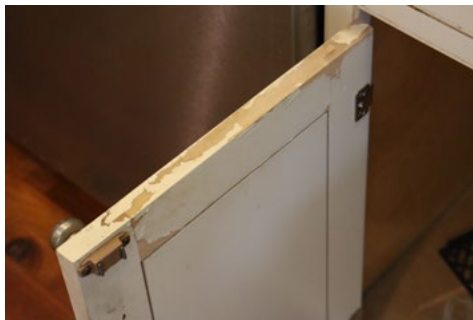
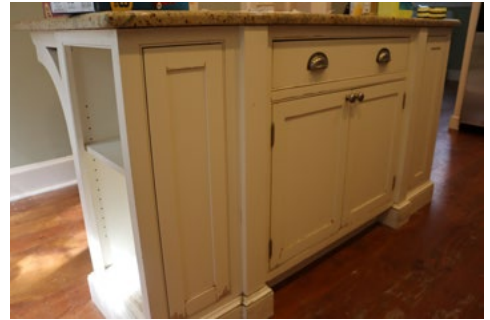
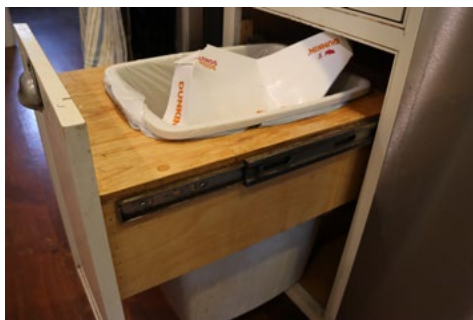
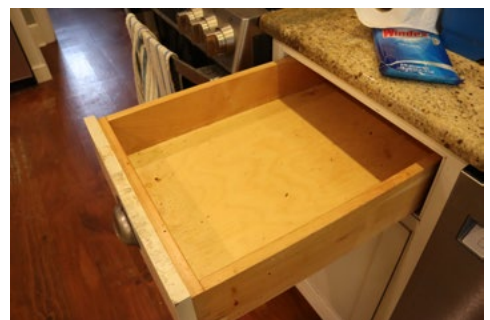
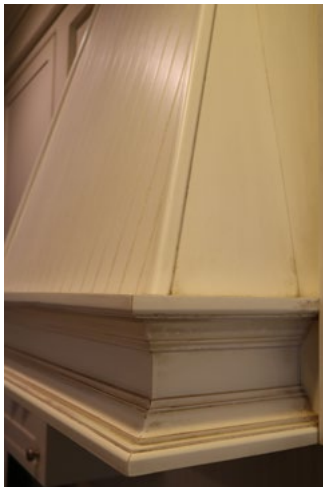
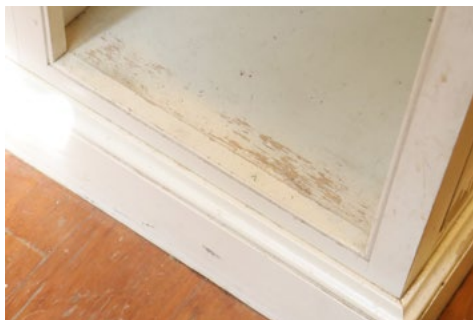
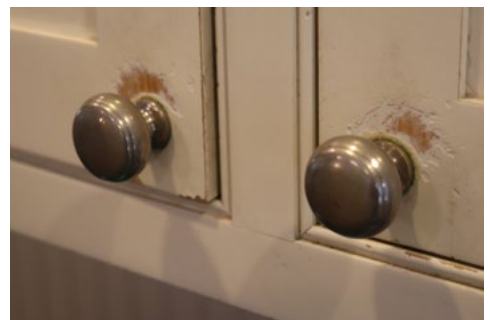
# Rectory Kitchen Cabinets

**Issue:** Paint on 12 year old Kitchen Cabinets has significant wear and tear, particularly on most cabinet doors and sink backsplash

**Solution:** Replace in kind, design TBD.

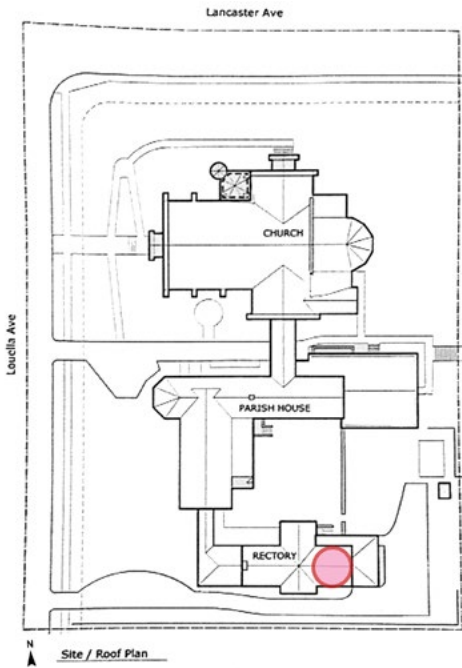
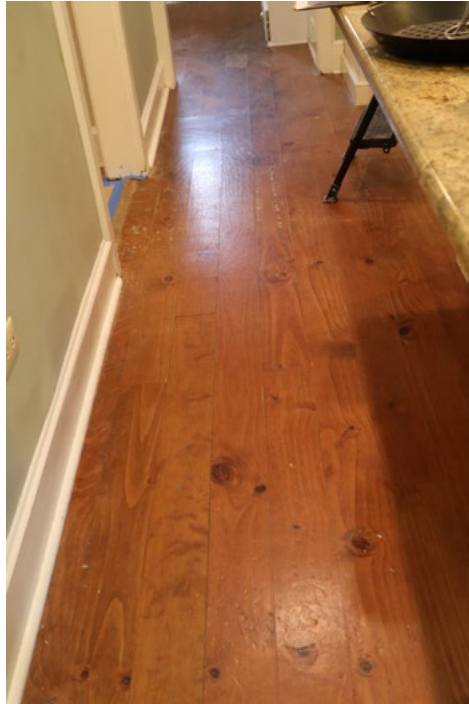
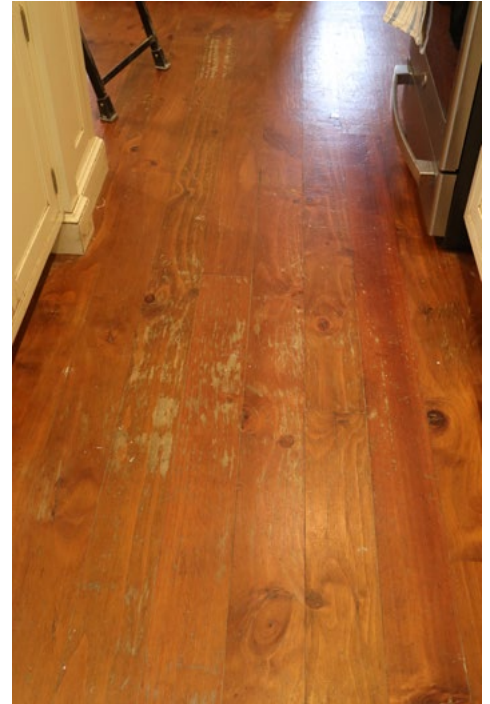
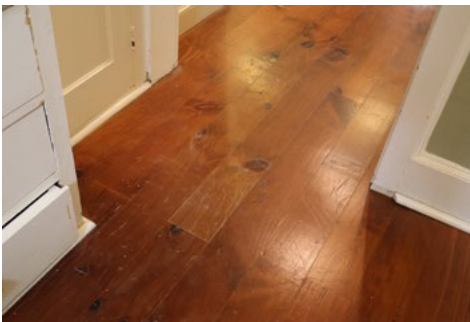
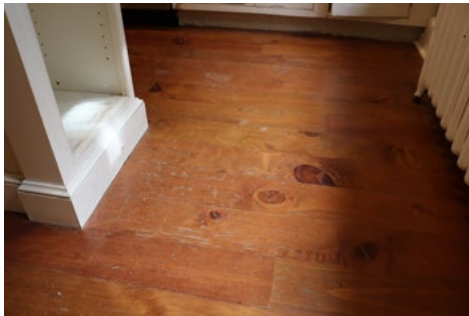
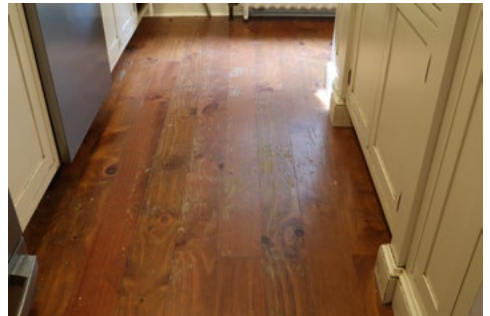
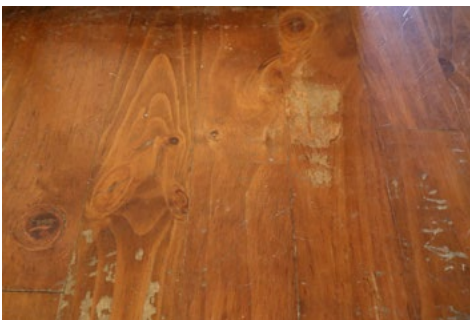
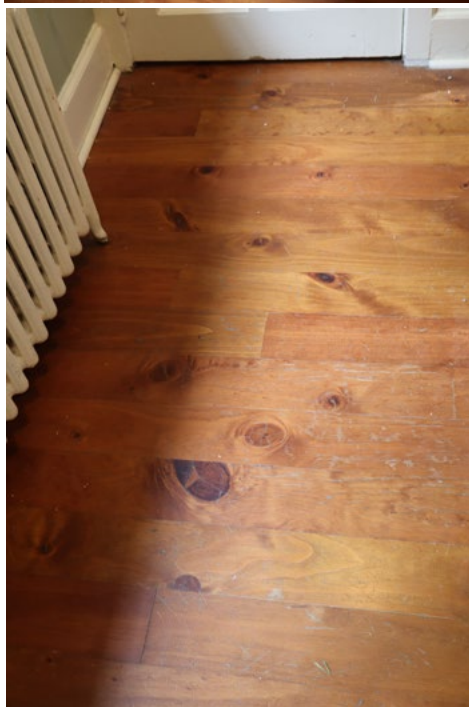
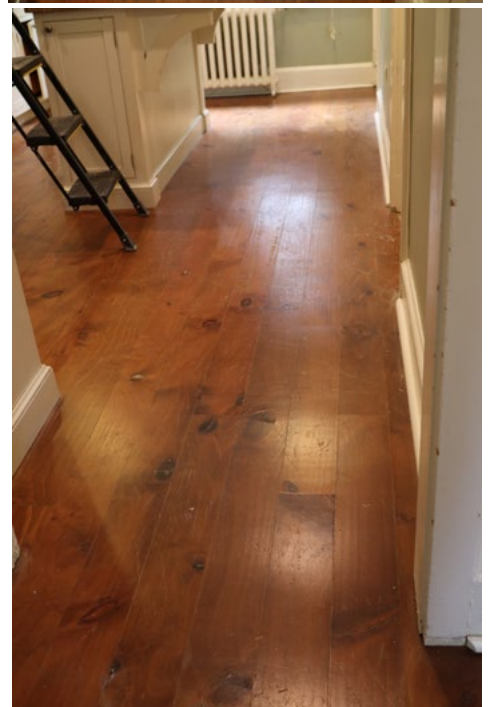
# Rectory Kitchen Floor

**Issue:** Finish/wear layer on laminated wood significantly floor worn.  
**Solution:** Remove and replace in kitchen and laundry, selection TBD.

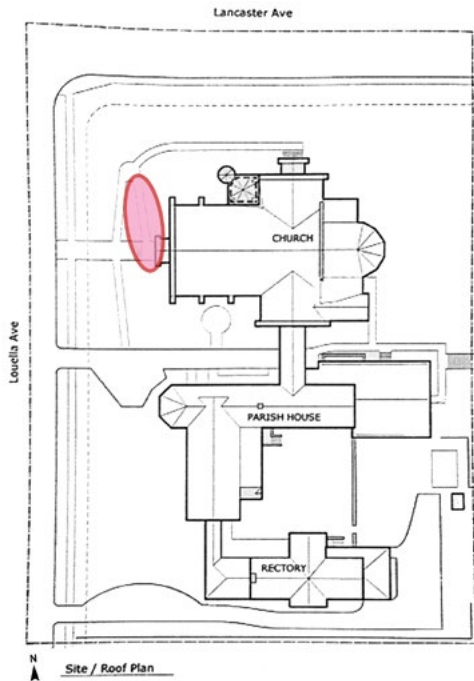
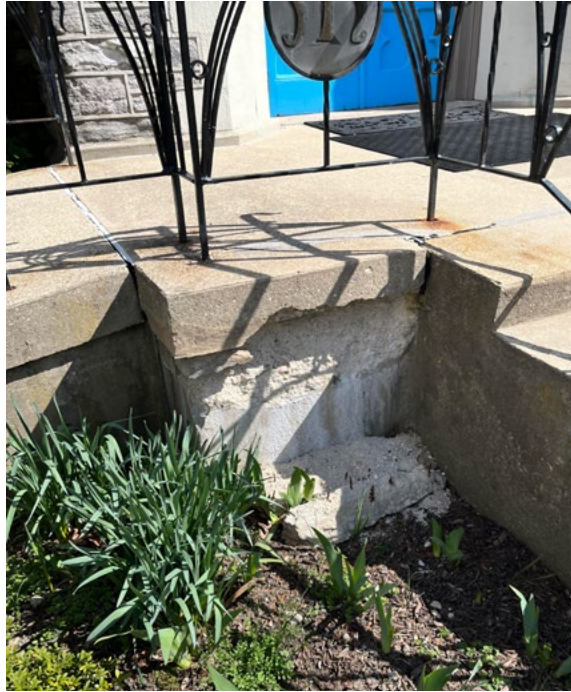
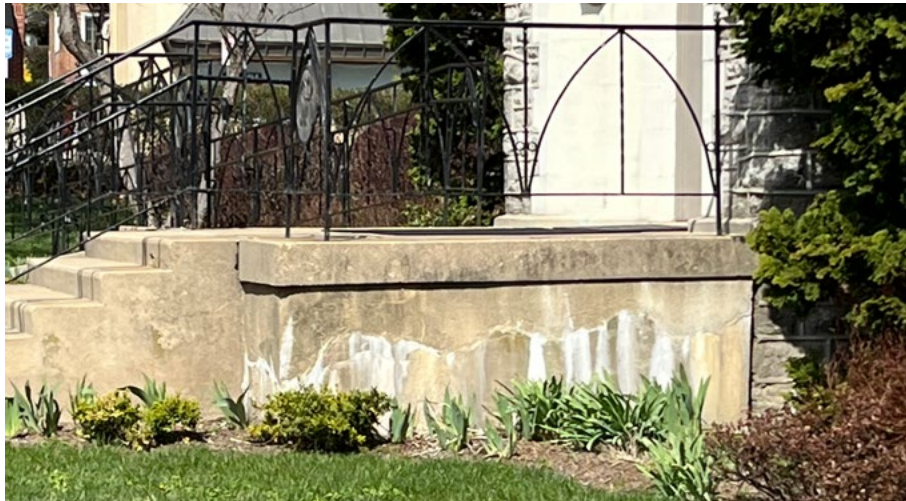
## Church Entrance Ramp

**Issue:** Moisture has penetrated the upper landing slab at the railing post penetrations, spalling has broken off a large chunk below the slab, cracks and rust staining visible in slab.

**Additional Attention:** Efflorescence is visible under landing slab on opposite side of stairs, solicit opinion on preventative maintenance to mitigate.

**Solution:** Hire concrete repair contractor to repair spalled section with embedded reinforcing and concrete. Perform preventative maintenance on railing penetrations.

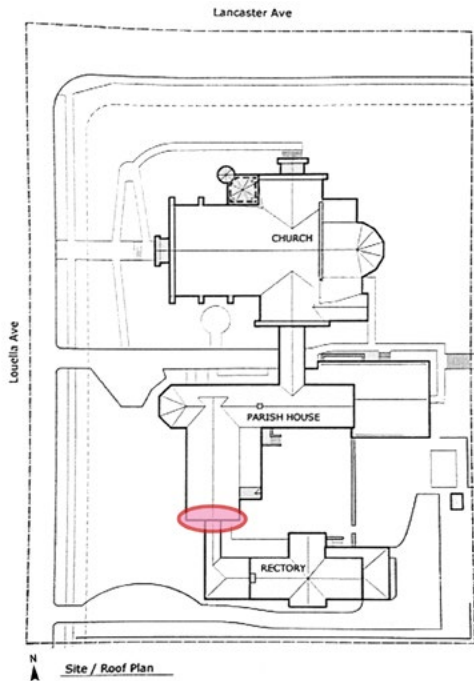
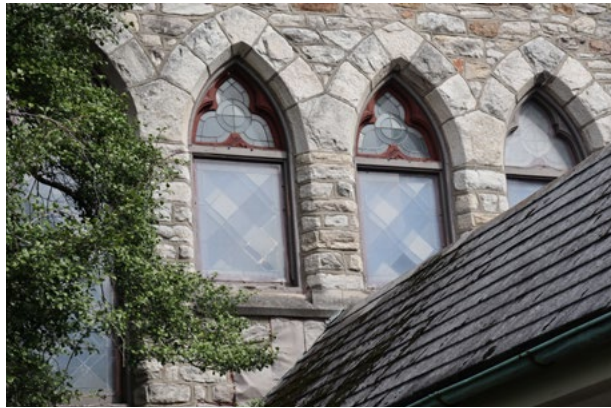
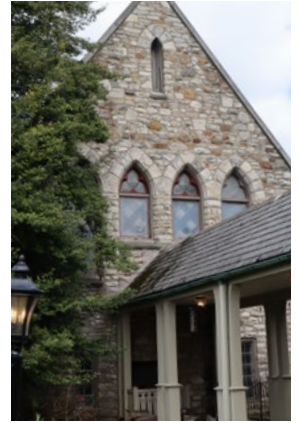
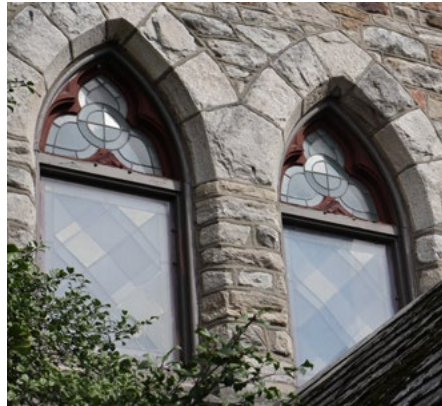
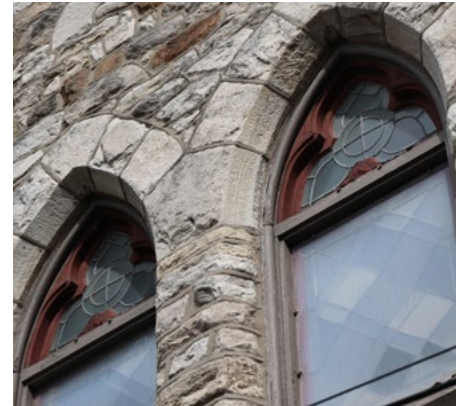
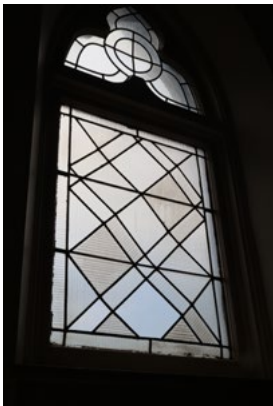
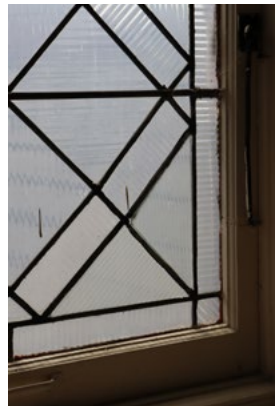
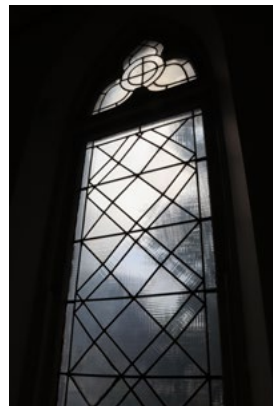
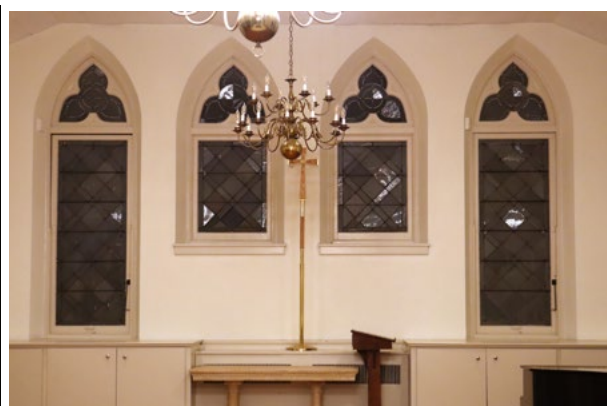
# Father Greene Room Windows

**Issue:** Lead came has deteriorated, some panes are working themselves loose, lexan protective sheet missing on two upper gothic-peaked transoms. exterior paint and wood trim deteriorating, lexan retainer clips may need to be replaced.

**Solution:** Hire stained glass shop to remove, re-lead and reinstall glass. Repair/replace exterior wood, paint and lexan.
